HITHER GREEN GOLF COURSE, HITHER GREEN LANE, REDDITCH

ARBORICULTURAL IMPACT ASSESSMENT

Report No: RT-MME-152753-02 Rev C

Date: February 2023

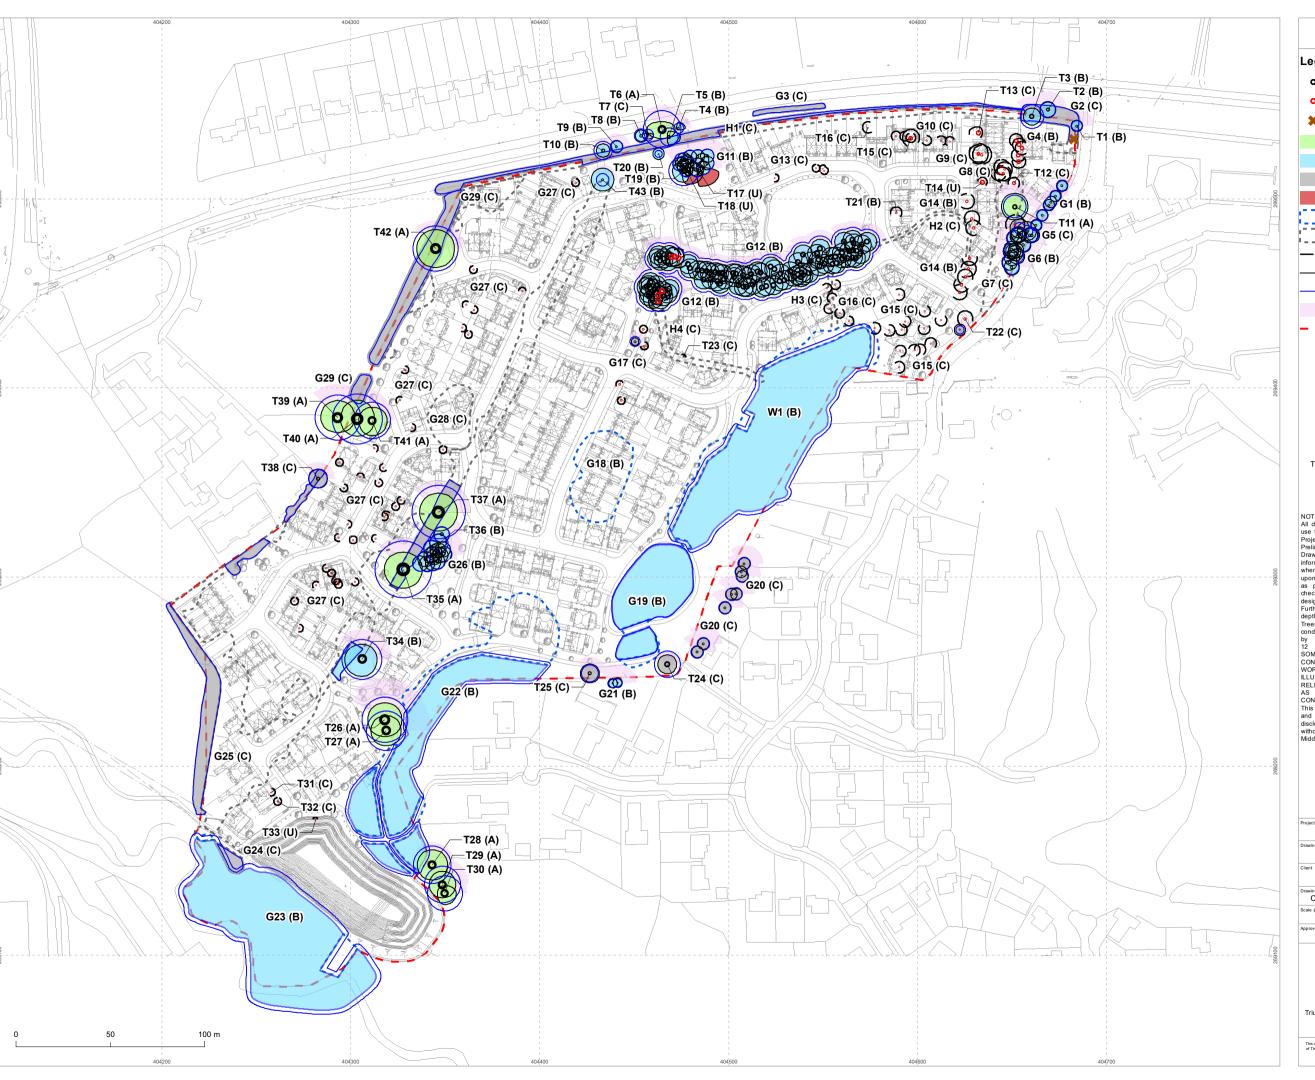
C152753-02-01-RevC

Tree/ Group/ Hedgerow/ Woodland Reference	Species	Retention Category	Reason for Removal
T12	Pear	С	Tree is situated within close proximity to proposed building.
T13	Lawson cypress	С	Tree is situated within footprint of proposed parking.
T14	Apple	U	Tree requires removal due to poor condition and location within footprint of proposed building.
T15	Grand fir	С	Tree requires removal due to location within footprint of proposed building.
T16	Ash	С	Tree requires removal due to location within footprint of proposed building.
T17	White poplar	U	Tree requires removal due to poor condition and health and safety risk due to location adjacent to proposed access road.
T18	White poplar	U	Tree requires removal due to poor condition and health and safety risk due to location adjacent to proposed access road.
T21	Silver birch	В	Tree requires removal due to location within footprint of proposed building and proposed parking.

T22	Norway maple	С	Tree requires removal due to proximity to proposed barrier and footpath.
T23	Silver birch	С	Tree requires removal due to location within footprint of proposed building.
T31	Alder	С	Tree requires removal due to proximity to proposed access road.
T32	Alder	С	Tree requires removal due to proximity to proposed access road.
T33	Cherry	U	Poor condition.
G2*	Mixed species	С	Group requires partial removal due to location within footprint of proposed building.
G4	Mixed species	В	Group requires removal due to location within footprint of and in close proximity to proposed buildings and proposed hard surfacing.
G5*	Leyland cypress	С	Group requires partial removal due to location within footprint of proposed building.
